Wild Rogue North

Watershed Analysis

Version 2.0

December, 1999

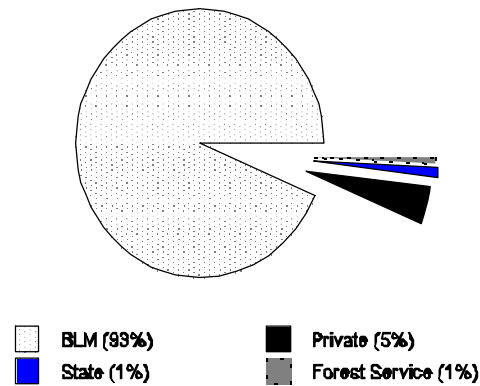
Figure 1: Land Ownership within the Wild Rogue North Watersh

The U.S. Forest Service manages 358 acres of land within the watershed (Figure 1). Other land owners include the State of Oregon, which owns 795 acres (1 percent of the watershed) and private land owners, who own 2,863 acres (5 percent).

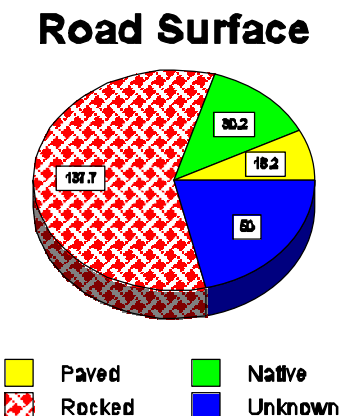
Figure 3. Road surface categories, Wild Rogue North watershed

Road information has been analyzed at the sixth-field watershed level in an effort to determine the areas of greatest management concern, those being upper Mule Creek and upper Kelsey Creek drainages due to the increased impact from past logging activities and high road density. Most harvest activities within this area occurred between the 1960s and late 1980s. Over time, some of the roads that were built in conjunction with these sales have deteriorated through slumping and lack of adequate road maintenance. Many of them are natural surface and short, “dead-end” roads, only providing access to landings.

In recent years, many of the roads in upper Mule Creek have been gated, which helps reduce motor vehicle use (Map 10). The gates also reduce maintenance needs due to problems which can arise from inappropriate use during periods of wet weather, such as increased erosion and sediment delivery, and problems which occur through heavy and prolonged use. Due to concerns regarding the high road density and the overall condition of roads in Mule Creek, an extensive inventory was conducted in recent years to determine culvert condition and replace failing culverts within the drainage. One culvert was determined to be a barrier to fish passage and was removed but not replaced. All other culverts that needed replacement were on non fish-bearing streams.
